**TAMARACK LAKE DAM "B"**

NDI No. PA 00746

May 1979

PHASE I INSPECTION REPORT  
NATIONAL DAM INSPECTION PROGRAM

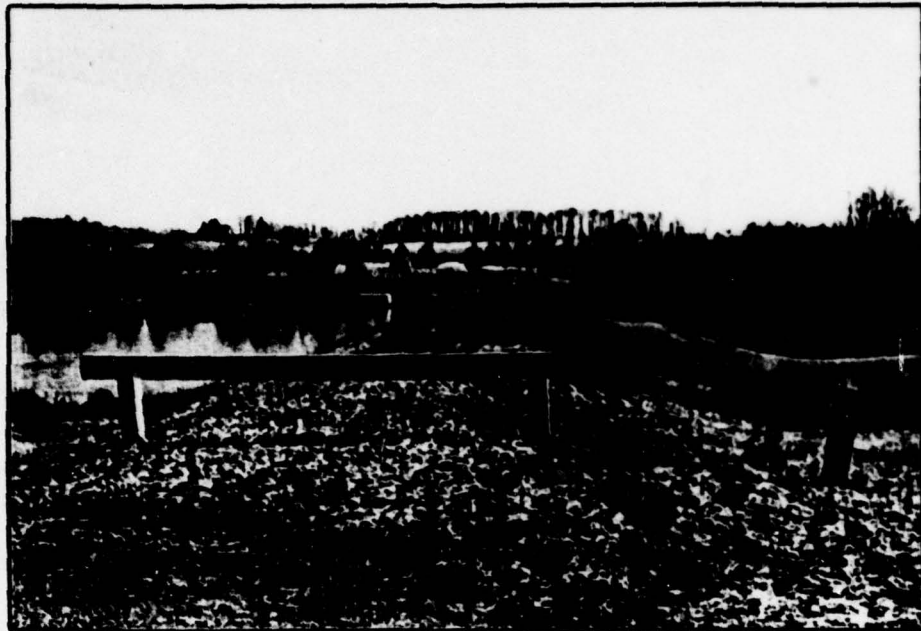
**Overall View of Dam from Right Abutment  
(Emergency Spillway Channel Located behind Trees in Left-Center of Photo)**

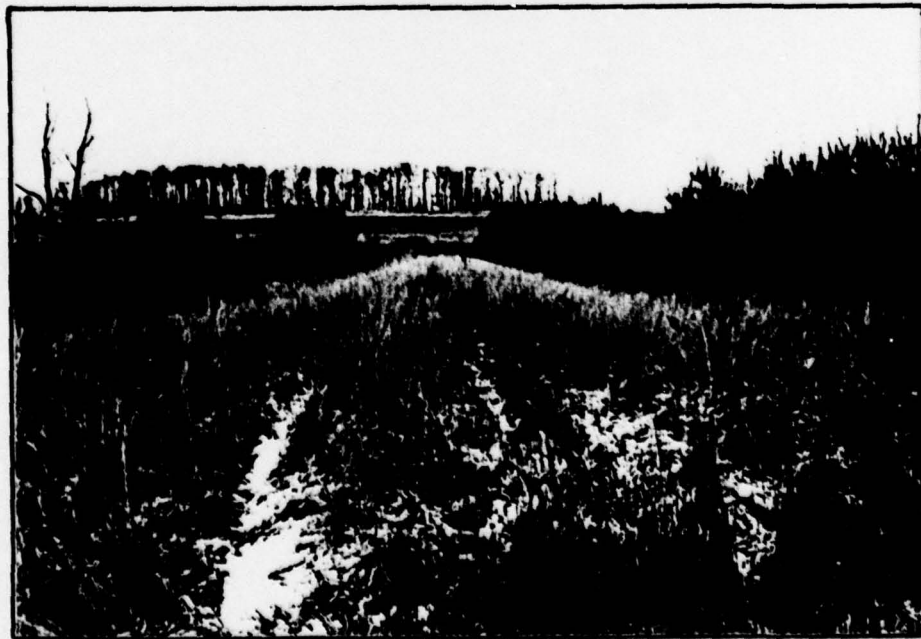
**Overall View of Dike from Right Abutment of Dike**

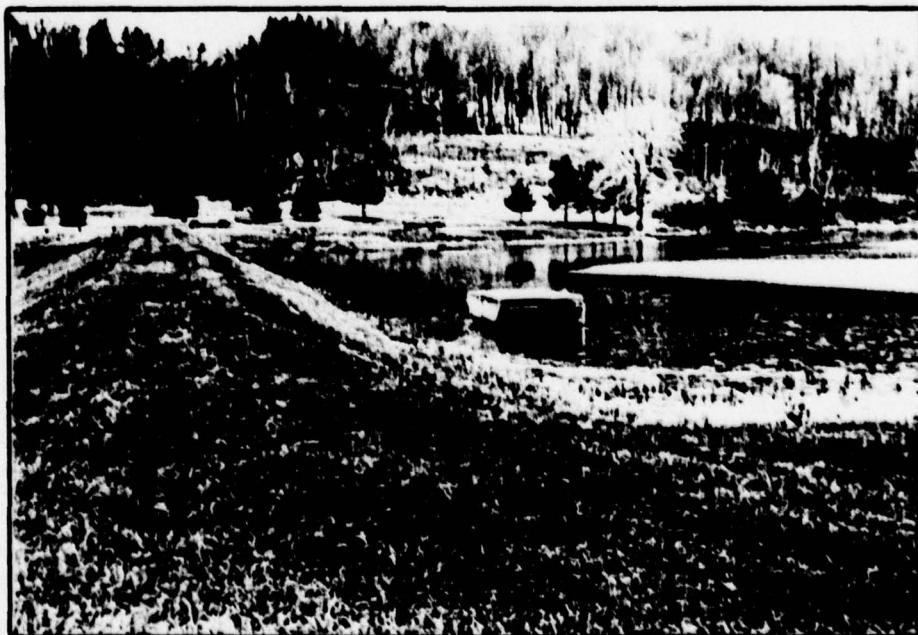
**PHOTO 2. View from Left Abutment of Dam**

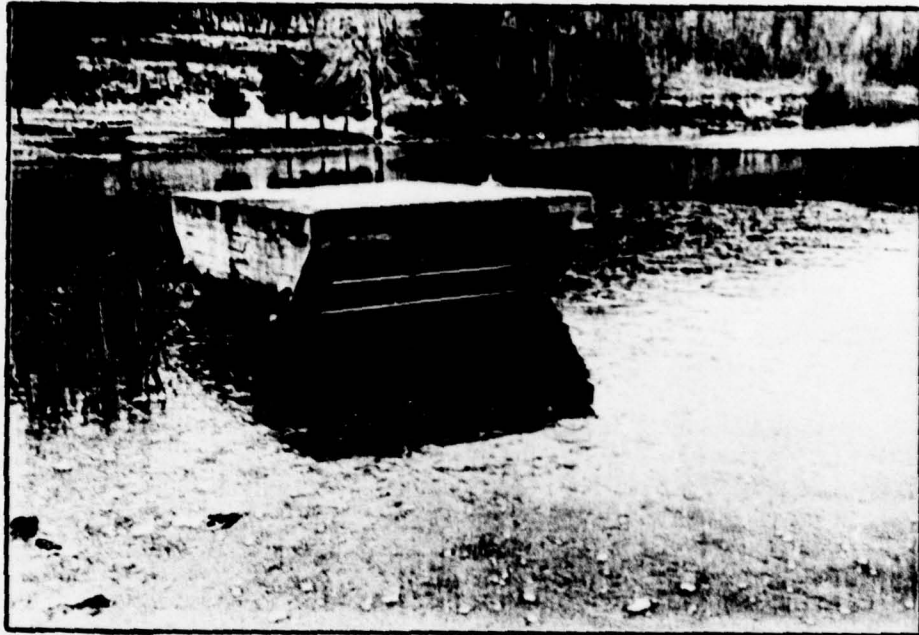
**PHOTO 3. Close-up of Intake Riser**

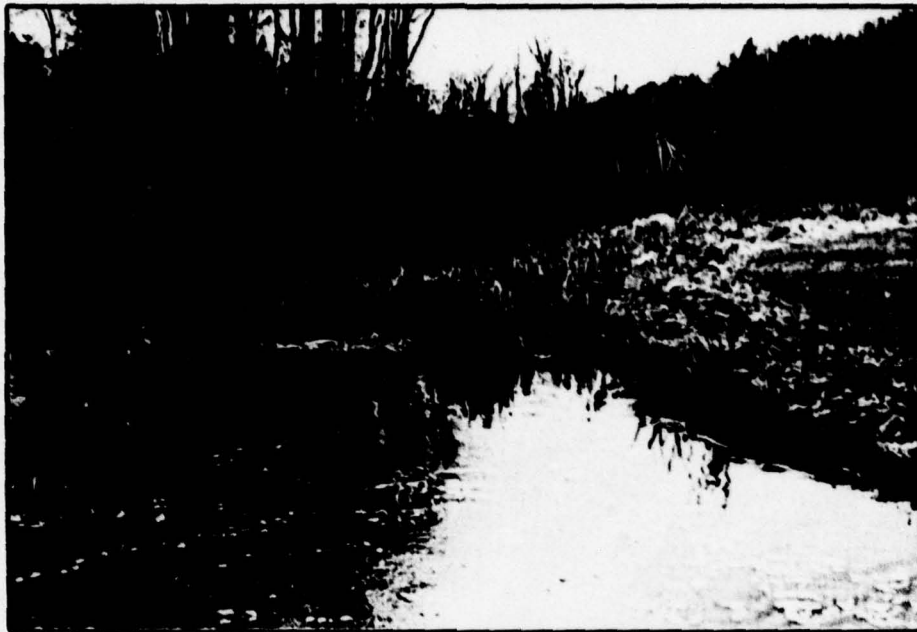
VISUAL EXAMINATION OF	OBSERVATIONS	REMARKS OR RECOMMENDATIONS
CONDITION (OBSTRUCTIONS, DEBRIS, ETC.)	No serious erosion or debris was noted in the downstream channel. There is, however, some vegetation located in the channel just below the stilling basin.	The downstream channel should be checked periodically for debris or other obstructions. The vegetation should be removed from the channel immediately downstream of the outlet pipe to minimize restriction of flood flows.
SLOPES	The slope of the downstream channel is mild, averaging approximately 0.3% from the dam to the confluence with Little Sugar Creek.	
APPROXIMATE NO. OF HOMES AND POPULATION	There are only a few homes located between the dam and the confluence of Mud Run and Little Sugar Creek, a distance of approximately 1.5 mi. The Little Sugar Creek floodplain is relatively uninhabited along its approximately 6.5 mi. course to the Borough of Cochranton.

**PHOTO 5. View of Downstream Channel (Note Vegetation in Channel)**

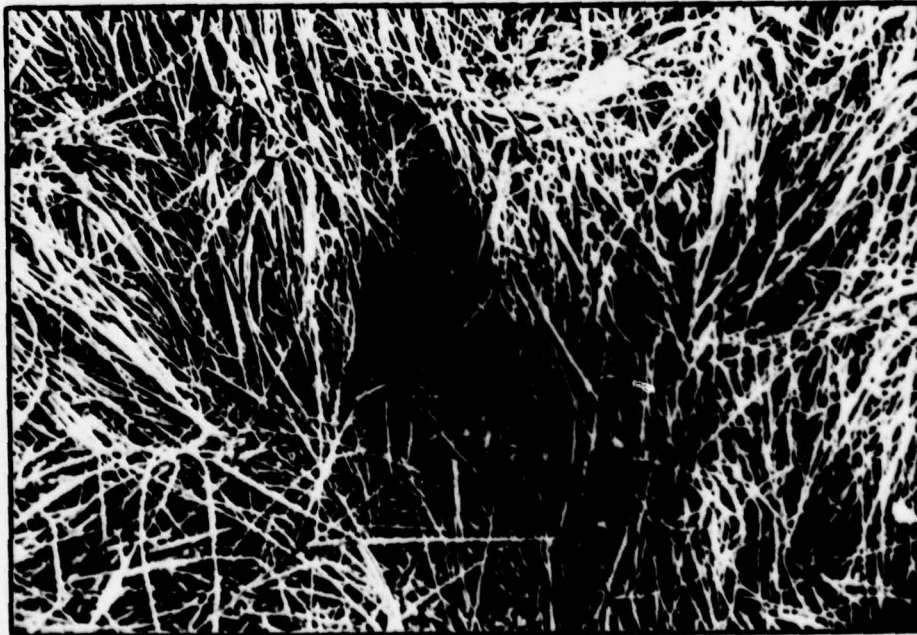
- b. Dam - Minor seepage was exiting approximately 20 feet left and 3 feet higher than the downstream end of the outlet pipe. A 4-inch diameter by 1-foot-deep hole was present at this location. Although this indicates that piping (internal migration of fine soil particles) may be occurring, no fine material was observed being transported by the minor amount of seepage at the time of inspection. It could not be determined how long this seepage has been occurring, but the vegetation indicates it may be of relatively recent development. (Note: The vegetation was green and lush and did not contain cattails or other identifiers of a long-term seepage condition.)

- a. Visual Observations - The seepage area noted during the visual inspection should be periodically examined in the future to verify that the quantity of seepage is not increasing and transportation of fine material is not occurring. Should the extent of the seepage area or characteristics of the seepage increase with time, the condition should be studied in detail and appropriate remedial measures taken.

**PHOTO 6. Close-up of Seepage Located to Left of Outlet Pipe**

- 1) The periodic inspection of the seepage area to identify a change in quantity or the exiting of muddy water from this area and, if necessary, to study the situation in detail and take appropriate remedial measures.
- 2) Remove the vegetation from the downstream channel.
- 3) Repair the animal burrows in the embankment and establish a rodent control program.
- 4) Place additional, properly designed riprap protection (or other appropriate measure) along the plunge pool to reduce the erosion.
